*CASE STUDY*

**USE OF iSOC<sup>®</sup> TECHNOLOGY AT  
PETROLEUM TANKER SPILL**

*SOUTHEAST, IOWA*

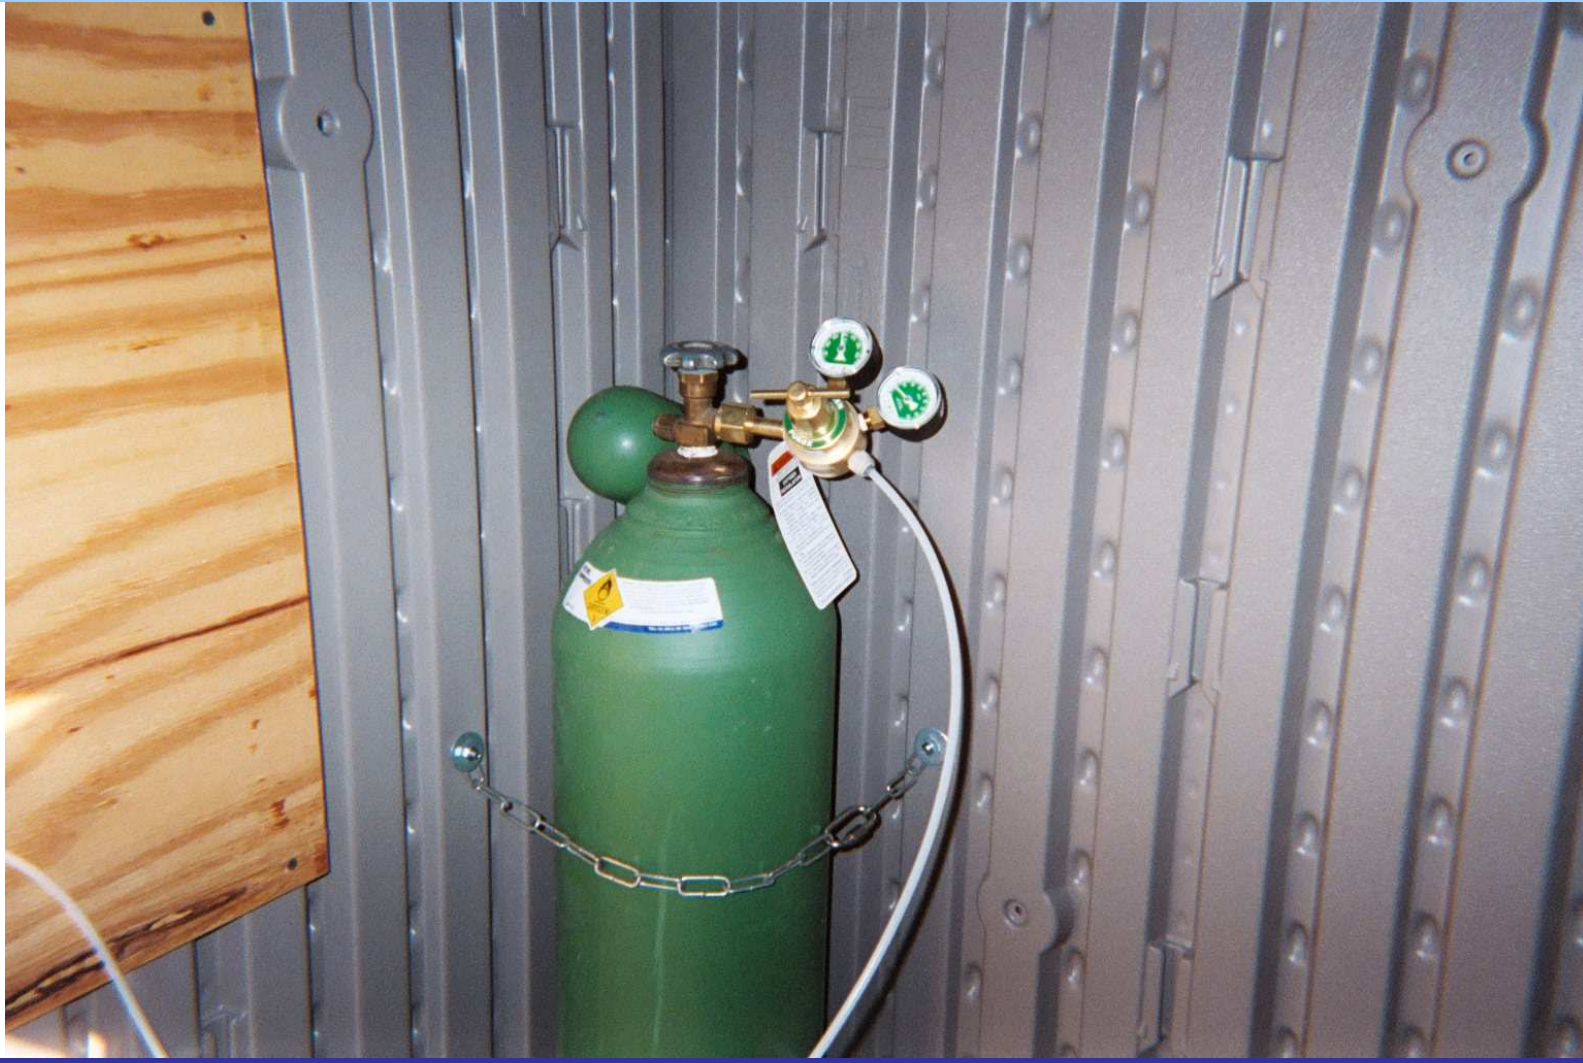
iSOC<sup>®</sup> System Gas Cylinder in the Remediation Shed

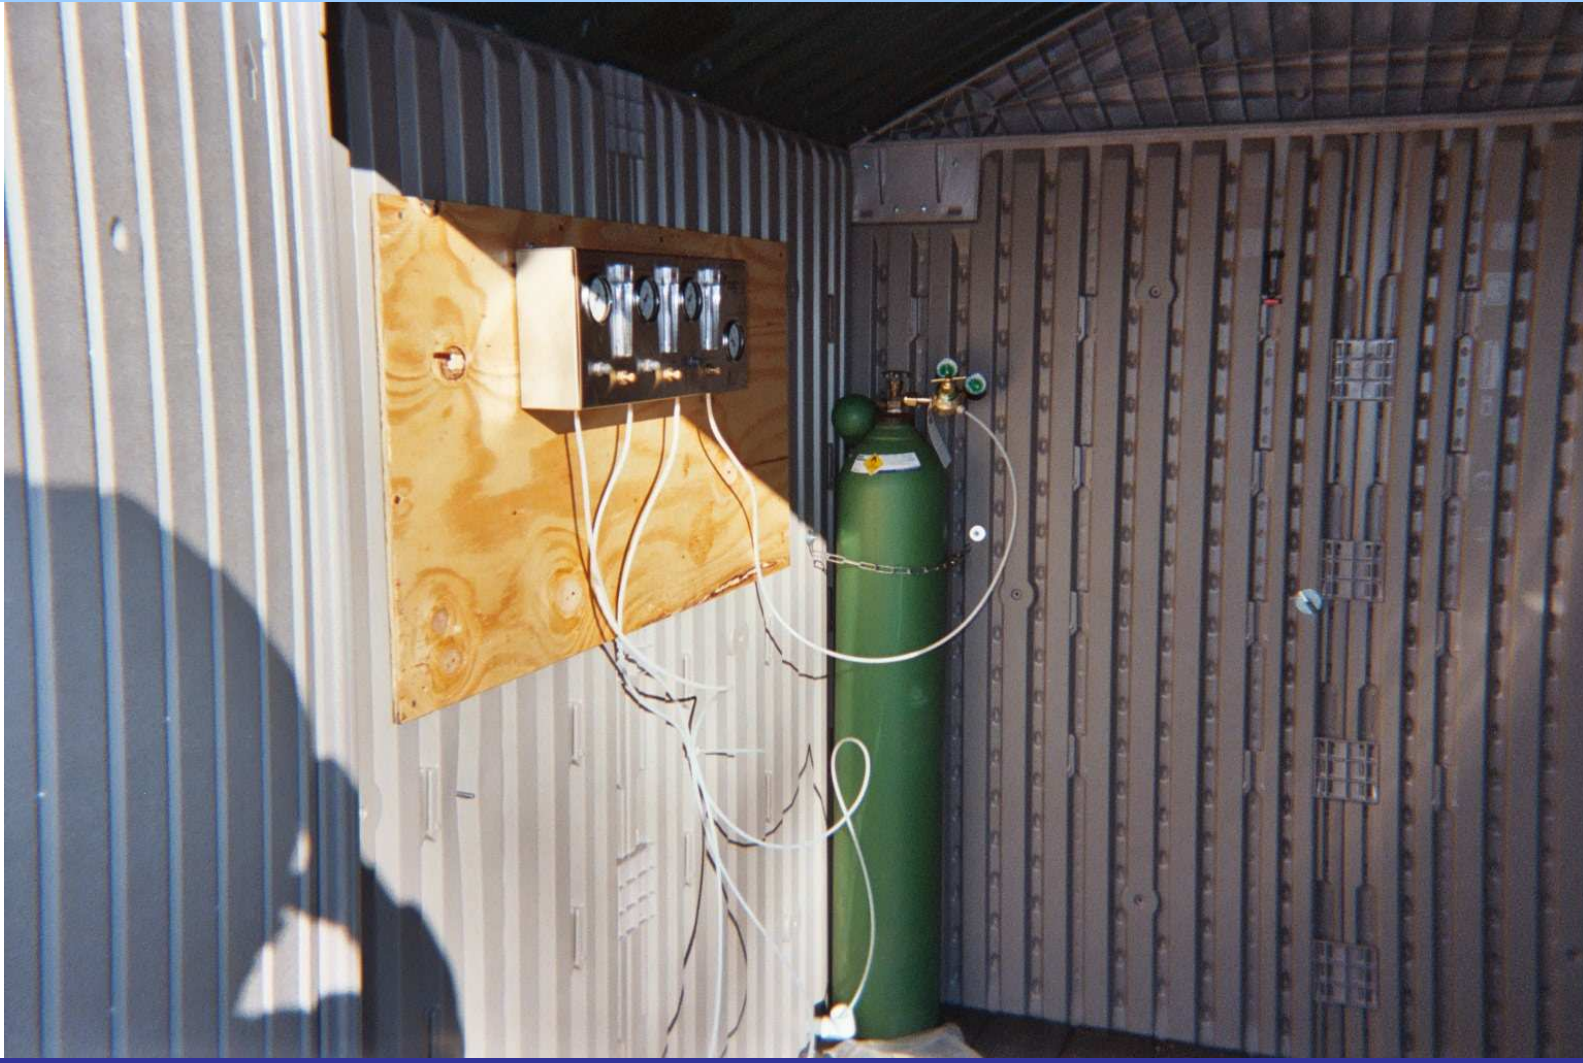
iSOC<sup>®</sup> System Control Panel in the Remediation Shed

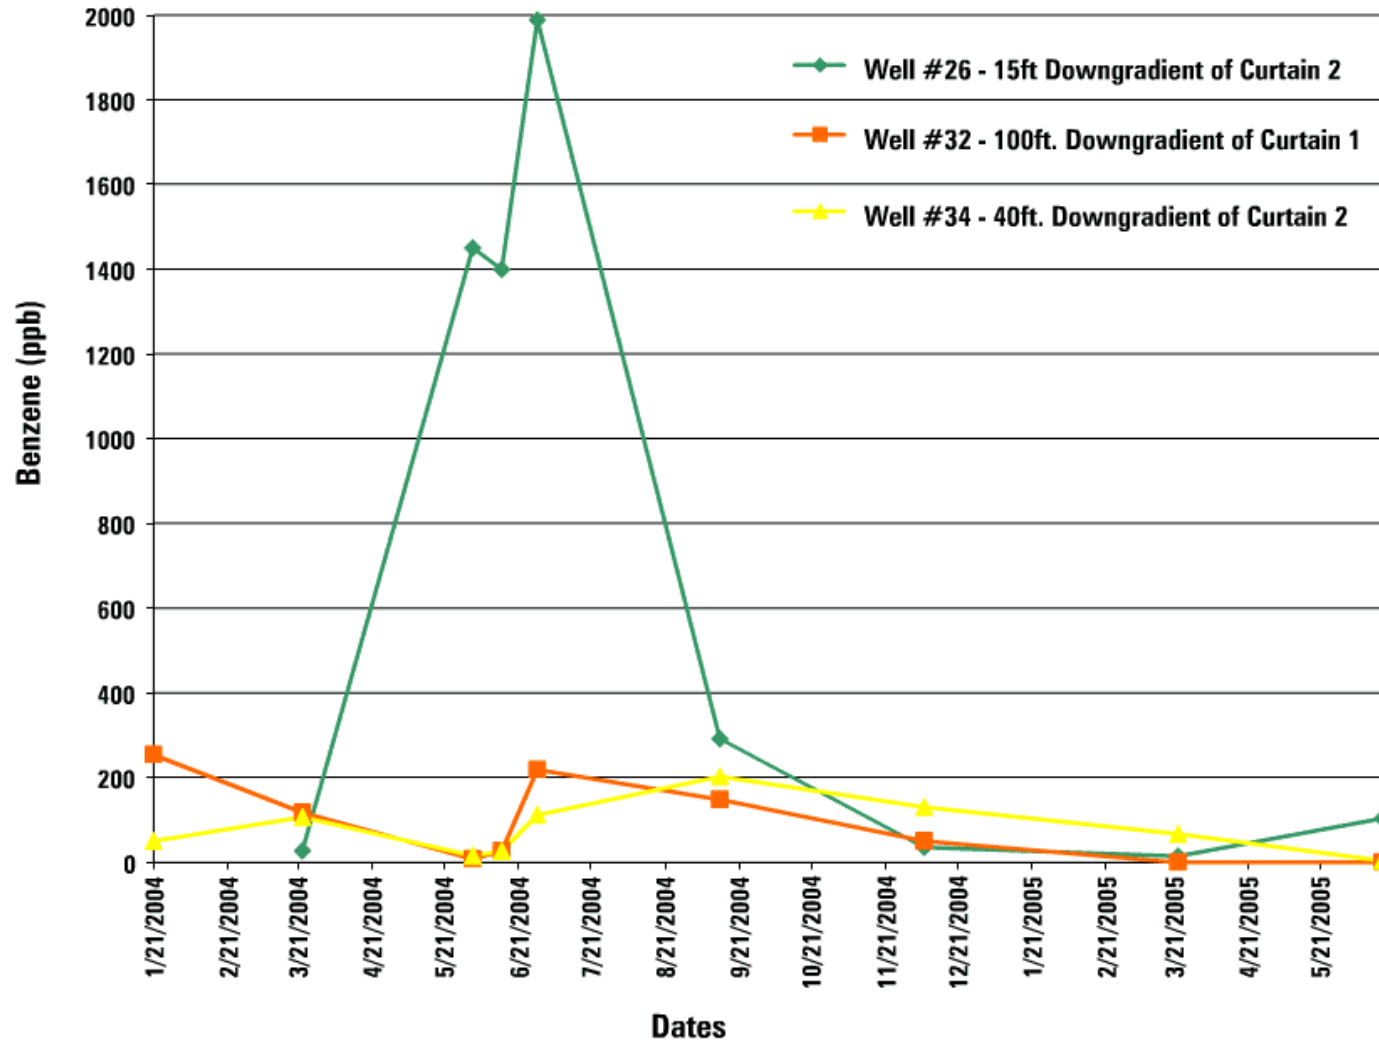
## Benzene Concentrations in MW 26, MW 32 & MW 34 (Curtains 1 & 2)

Date	Benzene	Toluene	E-Benzene	Xylene	MTBE
1/30/04	254	6	<1	7	12
3/23/04	117	5	<1	BDL	6
6/2/04	8	1	<1	BDL	2
6/14/04	26	BDL	<1	BDL	3
6/29/04	219	8	<1	62	11
9/13/04	148	1	<1	5	5
12/7/04	50	2	<1	BDL	BDL
2/23/05	BDL	BDL	<1	BDL	BDL
6/16/05	BDL	BDL	<1	BDL	BDL

Date	Benzene	Toluene	E-Benzene	Xylene	MTBE
5/16/03	1150	14	6.6	15	18
10/17/03	1130	17	BDL	6	36
3/23/04	27	BDL	BDL	BDL	19
6/2/04	1450	19	BDL	15	38
6/14/04	1400	24	BDL	BDL	34
6/29/04	1990	36	BDL	12	48
9/15/04	291	4	BDL	BDL	30
12/7/04	35	BDL	BDL	BDL	7
2/23/05	14	BDL	BDL	BDL	BDL
6/16/05	104	BDL	BDL	5	BDL

Date	Benzene	Toluene	E-Benzene	Xylene	MTBE
1/21/04	50	1	BDL	BDL	7
3/23/04	107	2	BDL	BDL	7
6/2/04	16	BDL	BDL	BDL	7
6/14/04	27	BDL	BDL	BDL	9
6/29/04	112	BDL	BDL	BDL	13
9/13/04	203	BDL	BDL	BDL	16
12/7/04	131	BDL	BDL	BDL	5
3/23/05	67	BDL	BDL	BDL	BDL
6/16/05	4	BDL	BDL	BDL	BDL
